Oakland Plantation Big House Historic Structure Report

CANE RIVER CREOLE NATIONAL HISTORICAL PARK
OAKLAND PLANTATION

~ BIG HOUSE ~

HISTORIC
STRUCTURE
REPORT

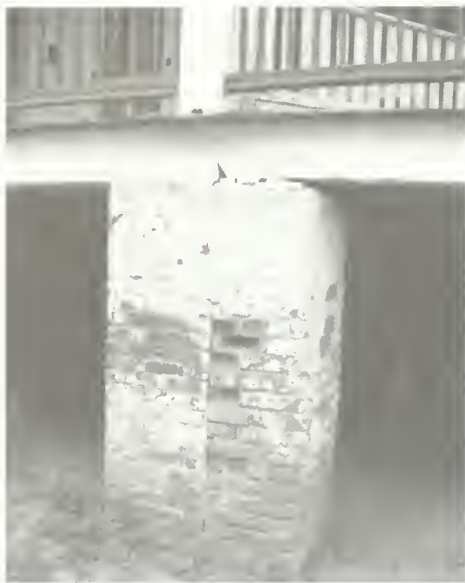
Figure 31 Brick piers on north end of east gallery. Pier at left is from the original house, c. 1821; pier at right is from the first expansion of the house, c. 1825. (NPS-SERO-CRS, 2001)

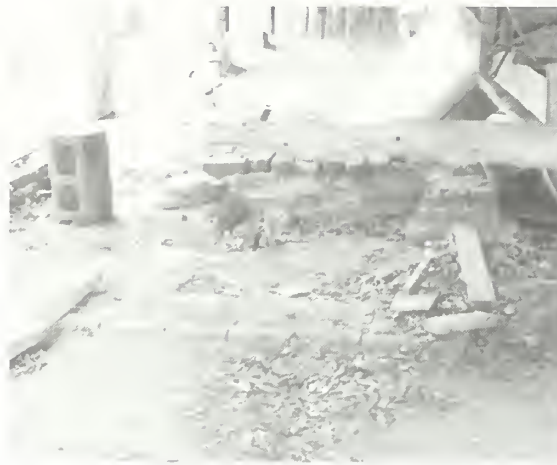
Figure 32 Demolished foundation for fireplaces under kitchen wing. (NPS-SERO-CRS, 2001)

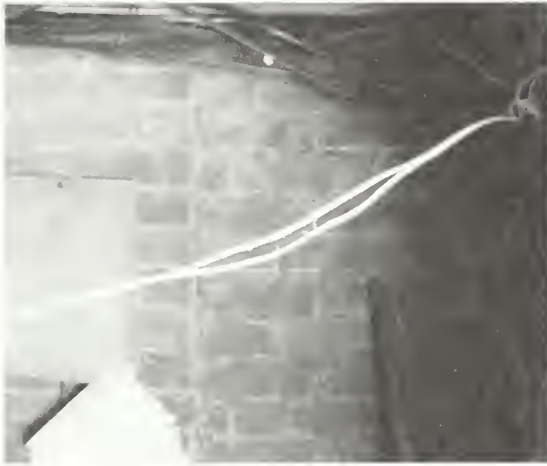
Figure 33 Detail of north wall of gas room (106), showing two earliest generations of brick work, both with mortar joints pencilled in white over red. (NPS-SERO-CRS, 2001)

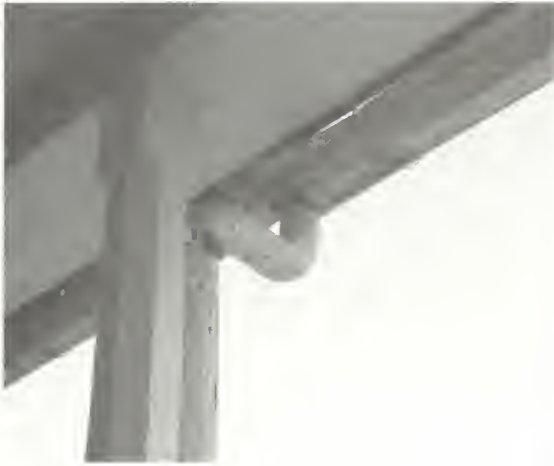
Figure 36 Typical semi-octagonal gutter and round downspouts, which date to early twentieth century. (NPS-SERO-CRS, 2001)

- Monitor effectiveness of current roof repairs and how frequently the coating requires renewal.
- If suitable replacements can be found, replace missing ridge shingles.
- Repair metal roofing and flashing; properly prepare both and repaint with appropriate silver-colored paint.
- Reinstate horizontal downspout at west end of kitchen wing.
- Repair existing gutters and downspouts, replacing only those portions that have rusted beyond repair.
- Keep gutters and downspouts painted, including the interior of the gutter trough. Exterior should be painted white; interior of gutter trough should be painted with appropriate rust-inhibitive coating.
- Insure rapid drainage of downspout runoff away from the house.

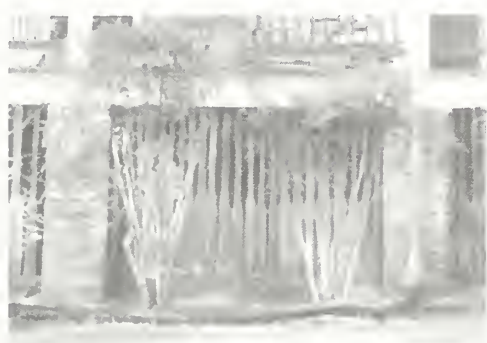
Foundation Enclosures: Before the Civil War, there was apparently no enclosure of the foundation piers around the perimeter of the house. The brick walls of the basement rooms remained clearly visible and were painted red with "pencilled" mortar joints. Fragments of that treatment can still be found in Room 106 (see description below) with red paint still visible on the brick at several other locations. The

Figure 39 Views of earliest type of foundation enclosures, (c. 1870). (NPS-SERO-CRS, 2001)

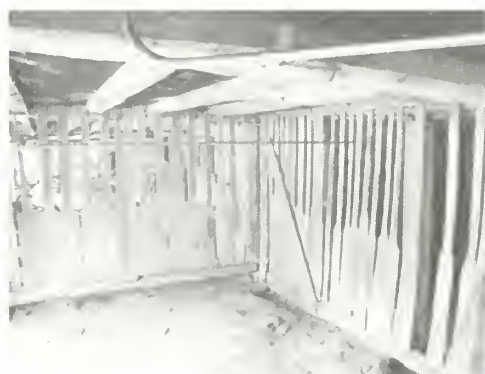
Figure 40 View of a somewhat of foundation enclosure. (NPS-SERO-CRS, 2001)

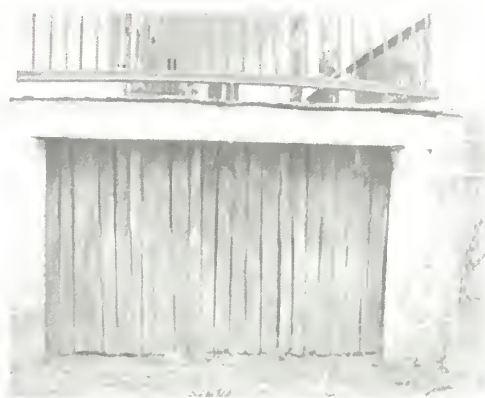
Figure 41 View of the third type of foundation enclosure. (NPS-SERO-CRS, 2001)

remain from the enclosure of that area. Horizontal boards (now covered with corrugated metal) above a grade-level course of brick are present beneath the west side of Room 214B. Wood-framed walls with horizontal planking were once present between the piers of the kitchen wing, but only fragments of the framing remain in place beneath the east end of the south side of the wing. These walls were reportedly removed in the 1940s.

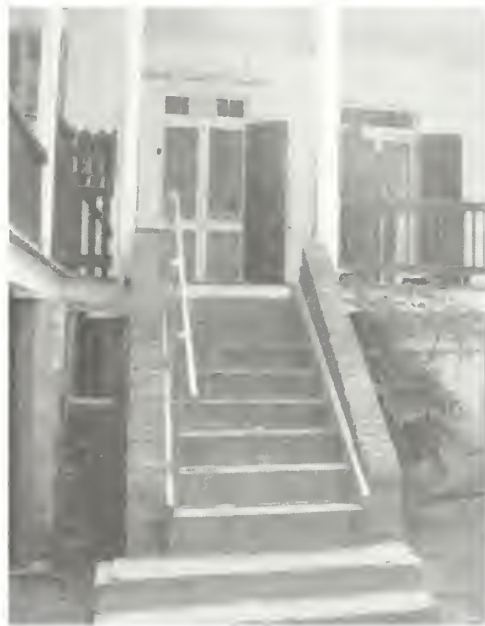
Figure 44 Brick stairs to rear gallery, shown here, and similar stairs to the south gallery replaced wooden stairs after World War II. Brick stairs to front gallery date to the nineteenth century. (NPS-SERO-CRS, 2001)

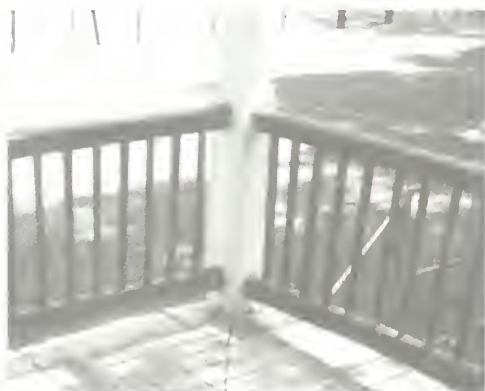
Figure 45 Typical gallery post, balustrades, and flooring. (NPS-SERO-CRS, 2001)

- Repair floor framing as necessary.
- Replace floor boards as necessary, replacing entire boards as has been done on previous occasions.
- Maintain protective coatings on balustrades and posts.

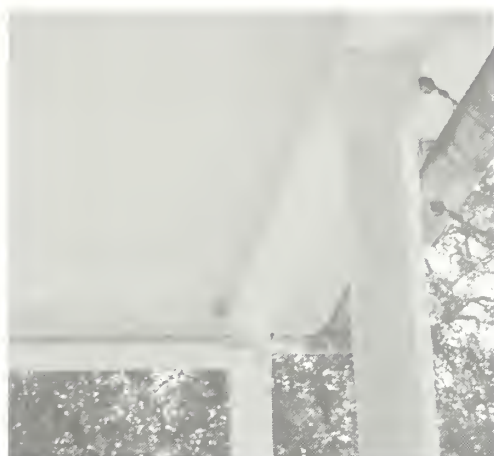
Figure 46 View of typical porch header and column top. (NPS-SERO-CRS, 2001)

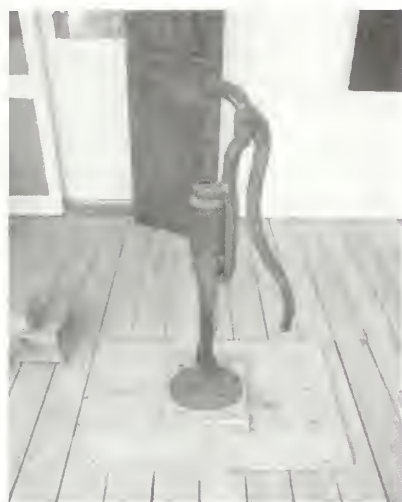
Figure 48 Myers pump on rear gallery, still connected to cistern located below. (NPS-SERO-CRS, 2001)

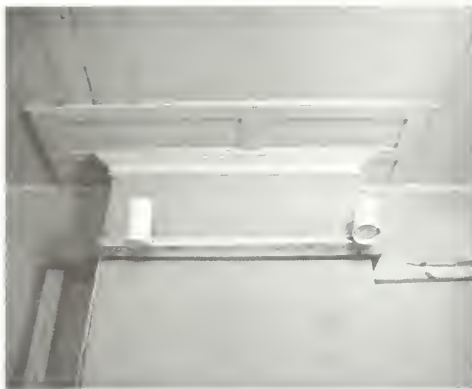
Figure 49 Board ceiling, typical of those found in most rooms on the main floor of the house. Paneling detail around chimney breast is typical of that found in 202, 205, 206, and 210, although molding details are different in each room. (NPS-SERO-CRS, 2001)

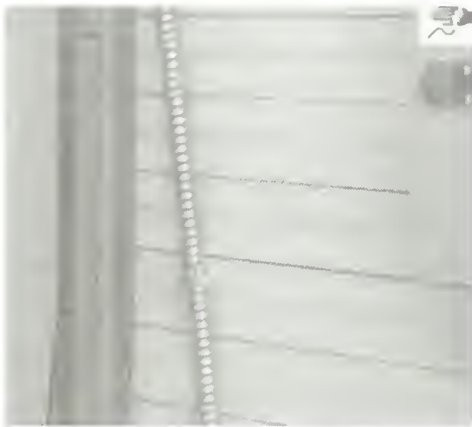
Figure 50 Typical beaded, tongue-and-groove boards used to panel parts or all of walls and ceilings in 202, 204, 207, 209, 215, and 216. (NPS-SERO-CRS, 2001)

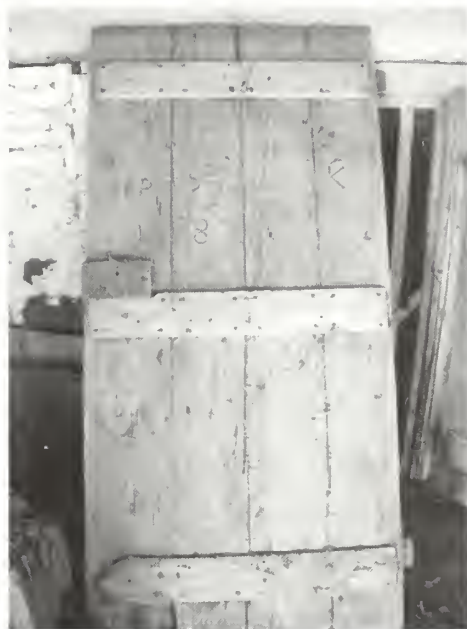
Figure 51 View of board door at basement level, typical of the oldest doors in the house. (NPS-SERO-CRS, 2001)

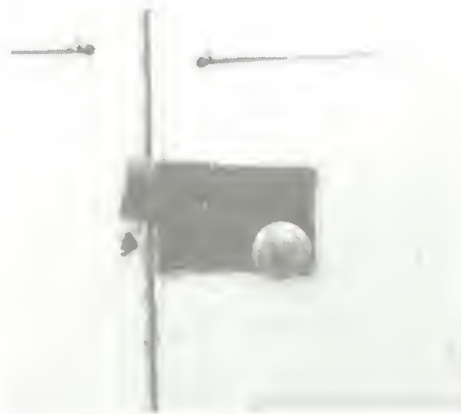
Figure 53 Early spring lock on French doors in dining room. (NPS-SERO-CRS, 2001)

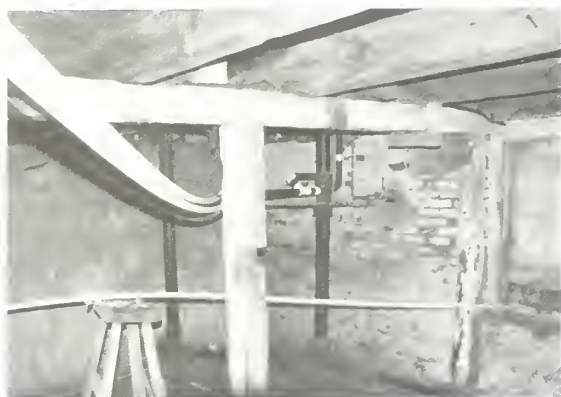
Figure 54 View southeast in Room 101, showing plumbing lines from bathroom 203. (NPS-SERO-CRS, 2001)

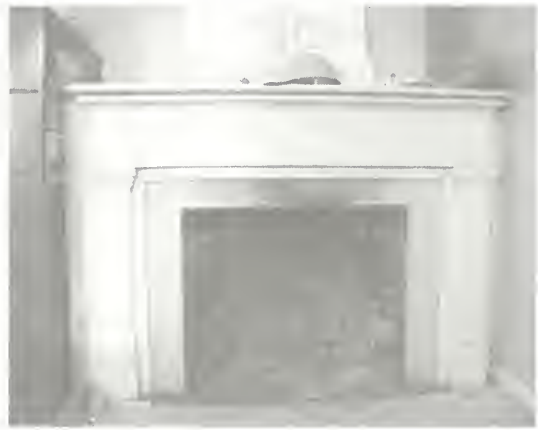
Figure 69 Top, view of mantle piece in master bedroom; below, view of chimney breast and ceiling paneling. (NPS-SERO-CRS, 2001)

present closet (Room 204) in 1953 was built flush with the breast of the fireplace and required shortening of the mantle shelf. The interior of the firebox has been rebuilt with modern fire brick, probably in the 1950s when the hearth, which may have originally been stuccoed, was covered with a Portland- type concrete. There is no ash dump or damper nor has the condition of the flue been evaluated. The mantle dates to the late nineteenth or early twentieth century when the original black

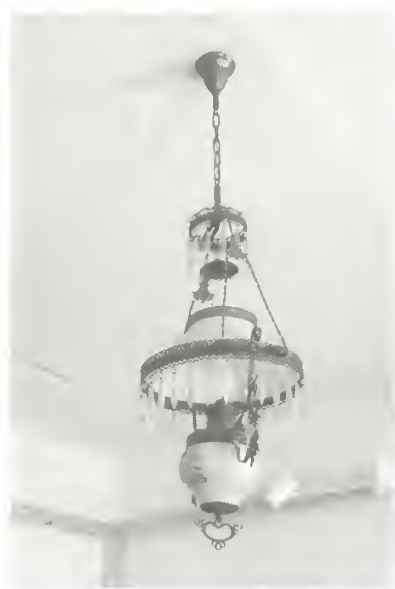
Figure 78 View of electrified kerosene chandelier in parlor. (NPS- SERO-CRS, 2001)

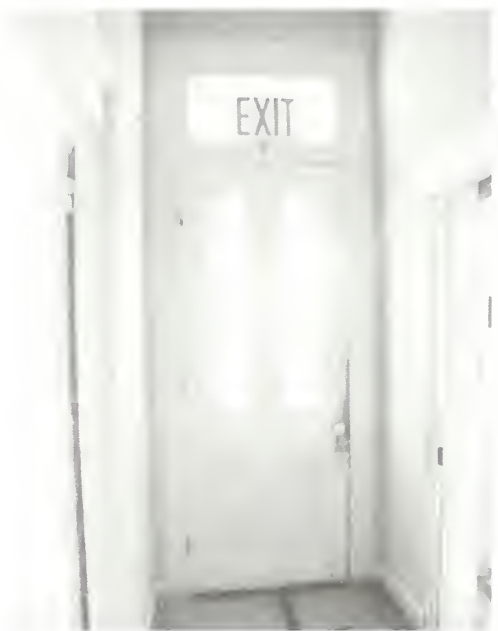
Figure 85 View of front door, installed as part of 1880s renovation. (NPS-SERO-CRS, 2001)

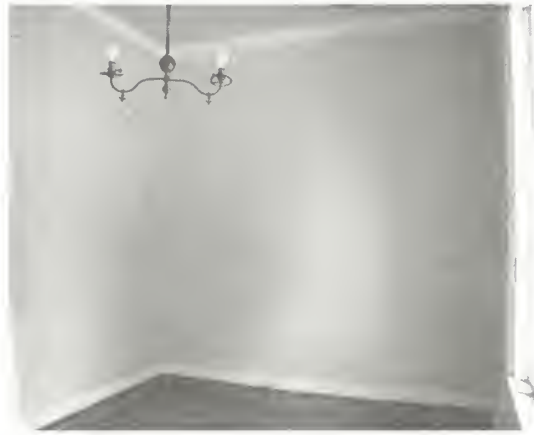
Figure 94 View southwest in stranger's room, showing window that was closed when sitting area was created at north end of kitchen in 1964. (NPS-SERO-CRS, 2001)

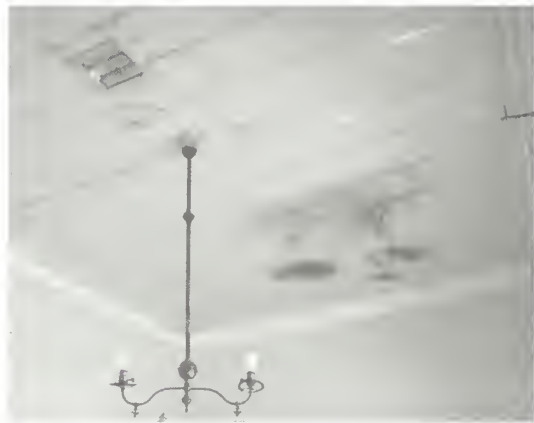
Figure 95 View of water-damaged ceiling in stranger's room. (NPS-SERO-CRS, 2001)

- Clean cypress and pine floors; refinish as necessary.
- Replace vinyl floor covering in kitchen, matching pattern and material of existing covering.
- Repair plaster and woodwork as necessary.
- Clean all painted finishes, using the gentlest means possible.
- Repaint ceiling in stranger's room (211) and elsewhere only as necessary.
- As an aid to interpretation, make exposures of historic paints inside and outside the house.

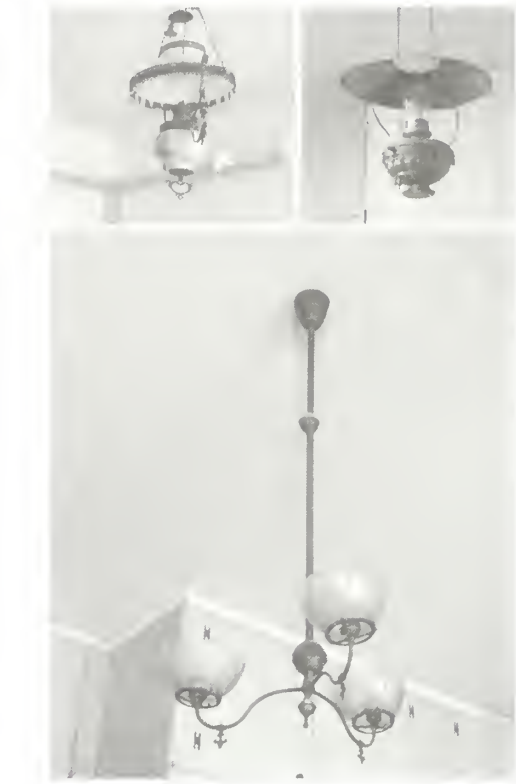
Figure 112 Top, view of nineteenth-century kerosene light fixtures and, below early twentieth-century gas light fixtures, all of which were converted to electricity in the late 1930s.

- Install new branch circuit wiring to re-feed historic outlets and to feed any new outlets that are deemed necessary.
- Restore and rewire historic lighting fixtures to working order, replacing missing elements as necessary.
- Recreate the historic meter, fuse boxes and associated wiring on south gallery.
- Install complete fire detection and security system.

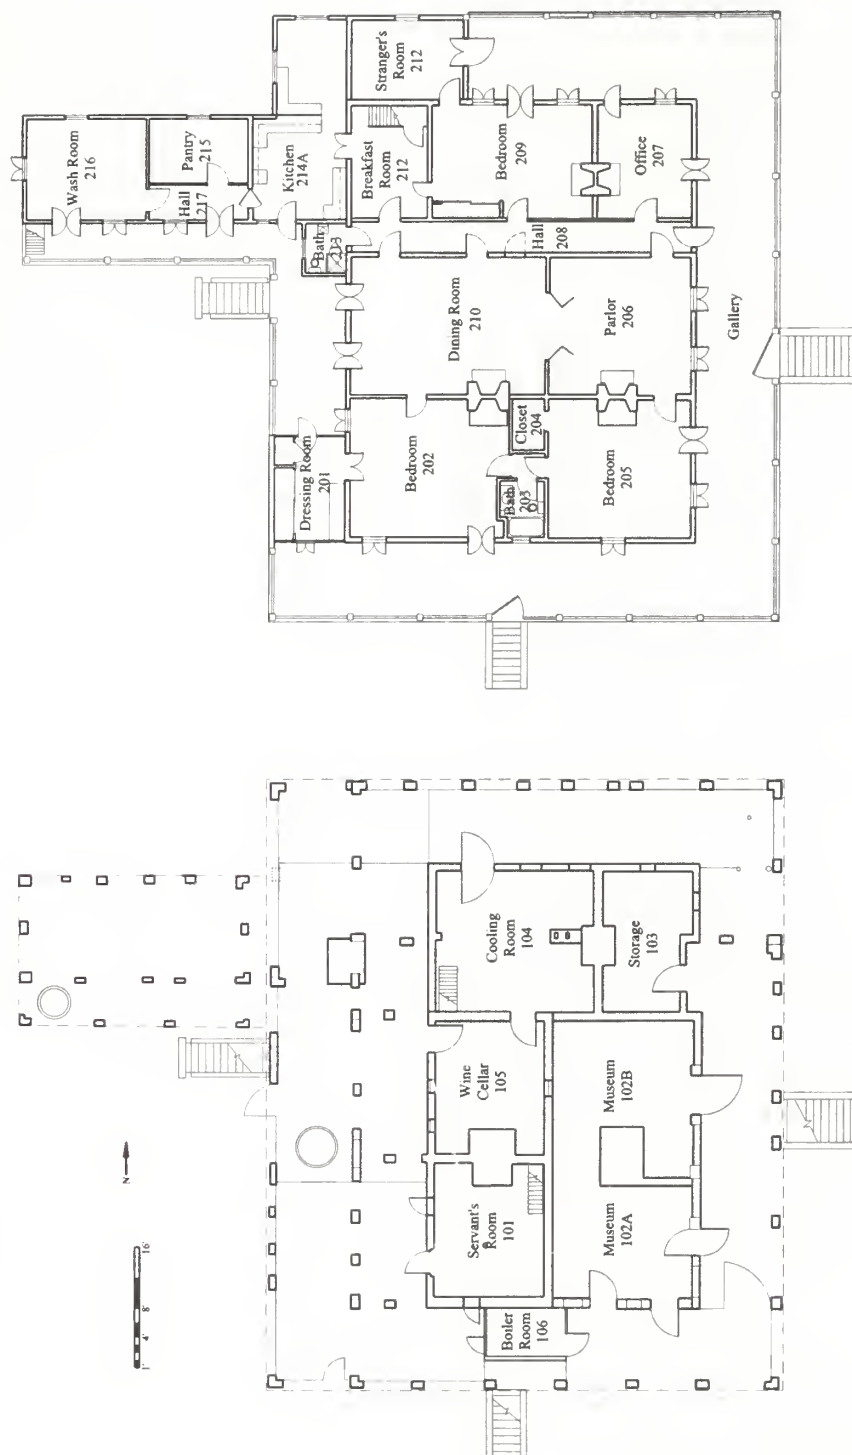
Figure 113 Plans of existing basement and main story of house. (NPS-SERO-CRS, 2001)
